**DEPARTMENT OF TRANSPORTATION**

Contract #: 04-0120F4Cty: SF/ALA Rte: 80 PM: 13.2/13.9File #: 69.28**WELDING INSPECTION REPORT****Resident Engineer:** Pursell, Gary**Address:** 333 Burma Road**City:** Oakland, CA 94607**Report No:** WIR-016363**Date Inspected:** 10-Aug-2010**Project Name:** SAS Superstructure**OSM Arrival Time:** 700**Prime Contractor:** American Bridge/Fluor Enterprises, a JV**OSM Departure Time:** 1900**Contractor:** Zhenhua Port Machinery Company, Ltd (ZPMC), Changxing Island **Location:** Shanghai, China**CWI Name:** Qiu Wen**CWI Present:** Yes No**Inspected CWI report:** Yes No N/A**Rod Oven in Use:** Yes No N/A**Electrode to specification:** Yes No N/A**Weld Procedures Followed:** Yes No N/A**Qualified Welders:** Yes No N/A**Verified Joint Fit-up:** Yes No N/A**Approved Drawings:** Yes No N/A**Approved WPS:** Yes No N/A**Delayed / Cancelled:** Yes No N/A**Bridge No:** 34-0006**Component:** Tower & OBG Components**Summary of Items Observed:**

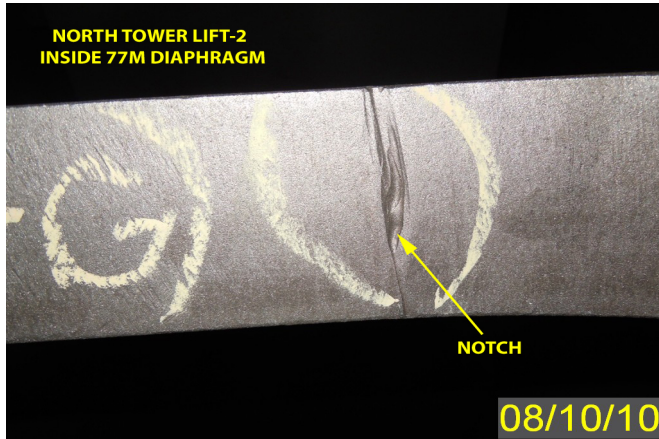
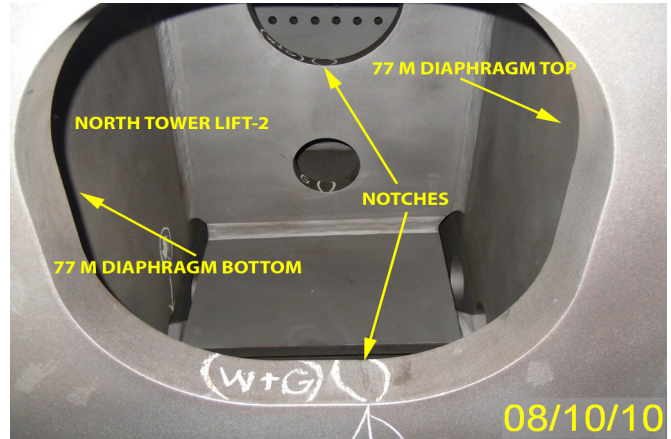
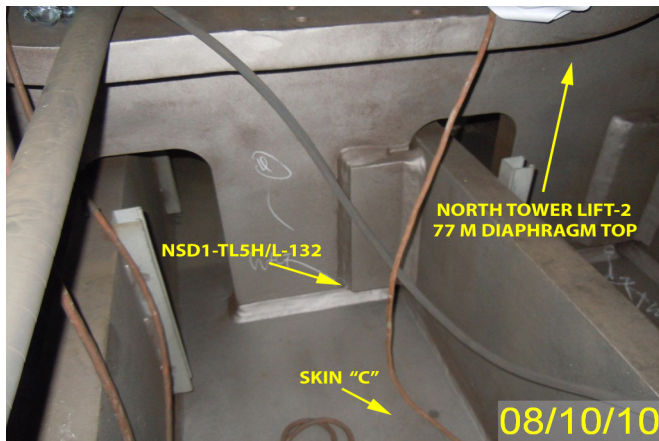
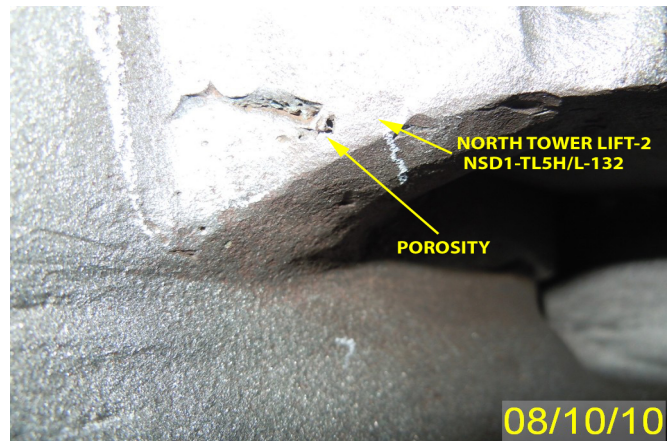
During the internal pre-blast visual inspection on North tower Lift-2, this Quality Assurance Inspector (QA) discovered the defects required welding and Magnetic particle testing on weld and base material at the following locations:

- Skin 'C' – Porosity – Weld # NSD1 – TL5 H/L – 132 and 134.

- Skin 'D' – Porosity – Weld # NSD1 – TL5 H/L – 157 and 190.
- Skin 'E' – Porosity – Weld # NSD1 – TL5 H/L – 96.
- 77M Double Diaphragm – 2 notches between the diaphragm.
